## Infrared Inspection Report Sheet

Customer:	<b>Sample Facility</b>	<u>Date</u> <b>09/01/08</b>	<u>Survey</u> <b>1</b>
-----------	------------------------	--------------------------------	---------------------------

<b>Item Inspected:</b>	Enclosed Circuit Breaker	<b>Location:</b>	Building A	<b>ID:</b> ECB-1
<b>Priority Codes</b>	<b>Alert</b>	<b>Severe</b>	<b>Critical</b>	<b>Delta T</b>
		X		
		<u>SP01</u>	<u>SP02</u>	<b>Temp Rise: 17.00 °F</b>
		Temp: 97.60 °F	Temp: 80.60 °F

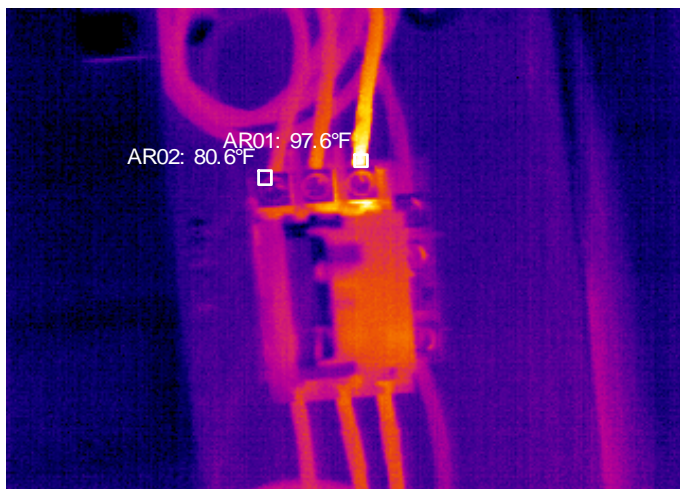
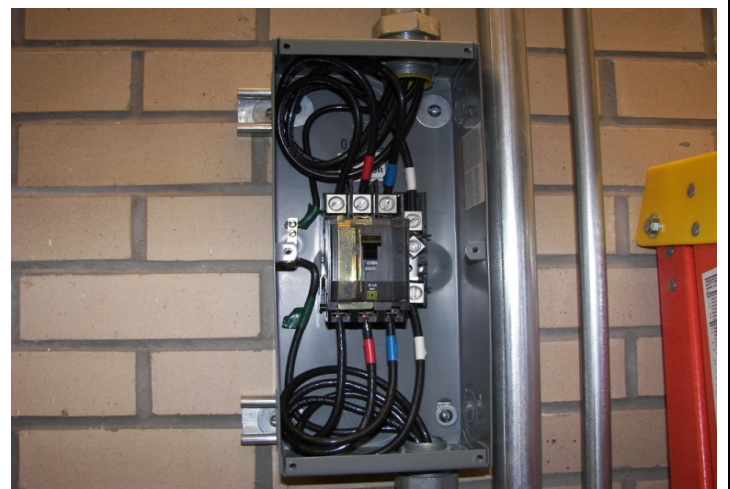
A Phase  
B Phase  
C Phase

C Phase on line side of 3-Phase, 60Amp breaker is hot.

<u>Label</u>	<u>Value</u>
<b>Problem:</b>	SP01	97.6 °F
<b>Reference:</b>	SP02	80.6 °F

De-energize, check connection, and repair or replace parts as necessary.
