Visual Discrepancies

Customer:	Sample Facility	Date 9/1/2008	Survey 3
-----------	------------------------	-------------------------	--------------------

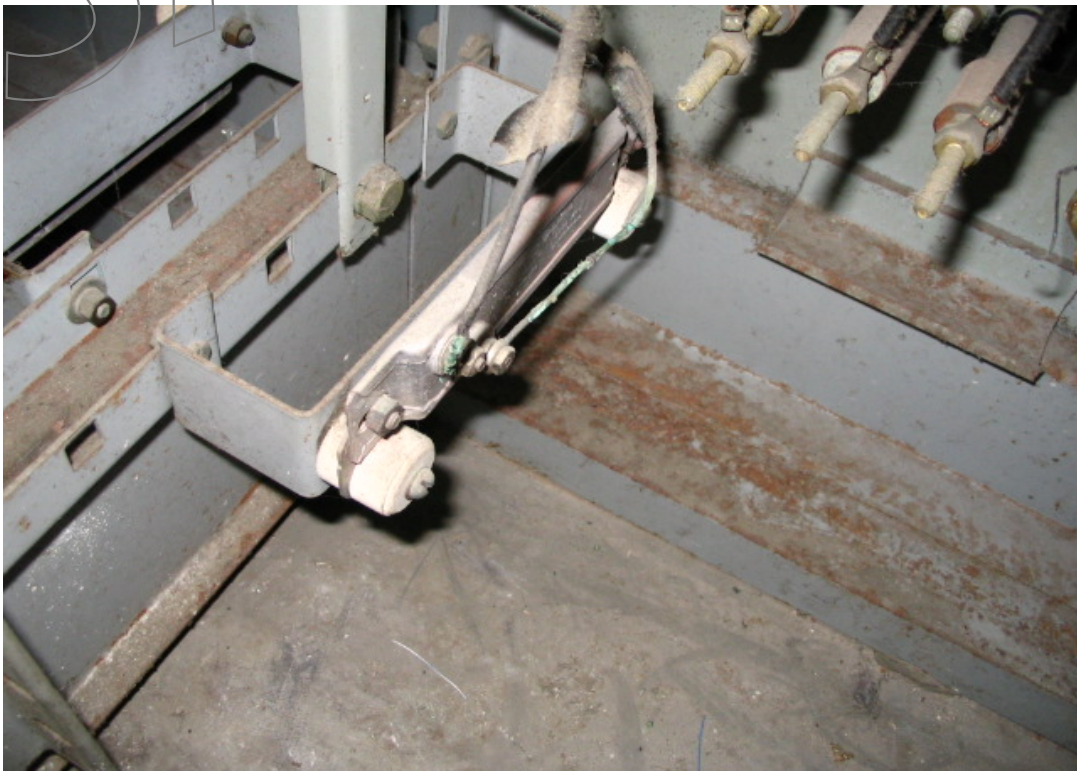
Discrepancy		
Item Inspected	Location	Equipment ID
Main Distribution Panel (1 HTR CP)	Main Electric Room	
Problem Description	Problem Solution	
Insulation is damaged.	Replace wire.	
Digital Camera Image
