Visual Discrepancies

Customer:	Sample Facility	Date 9/1/2008	Survey 5
-----------	------------------------	-------------------------	--------------------

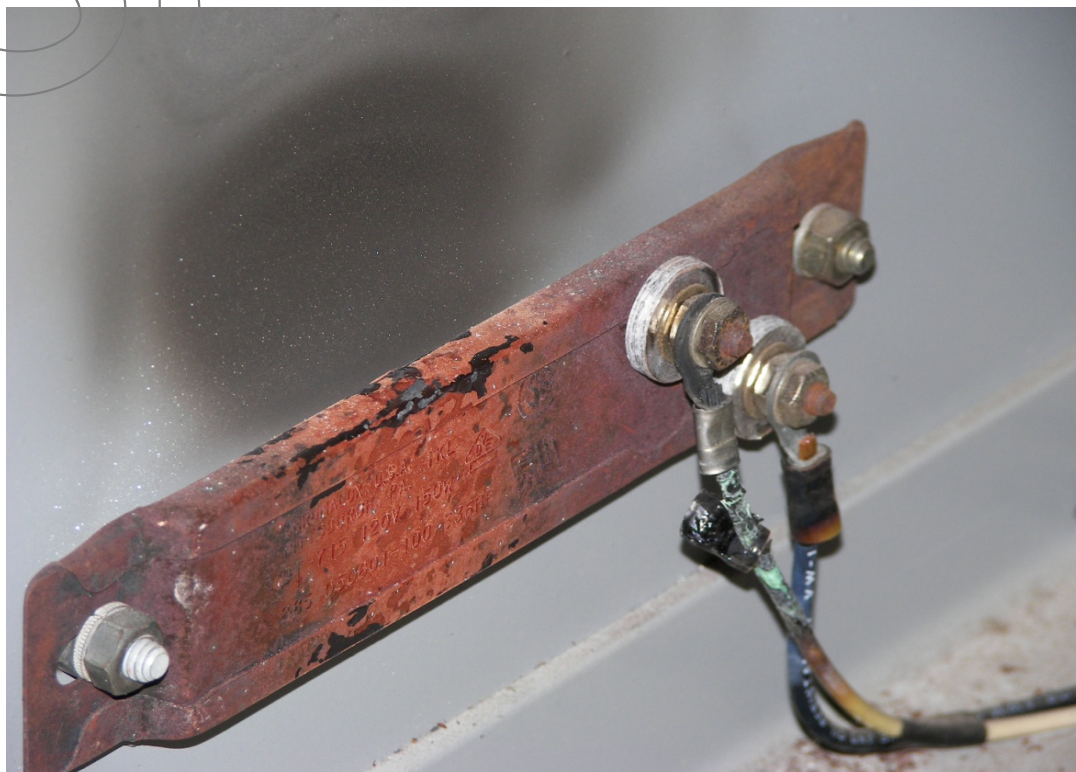
Discrepancy	
Item Inspected	Location
Siemens 300KVA Transformer	Main Electric Room
Problem Description	Problem Solution
Connections and wiring are burnt on the south enclosure heater.	De-energize and replace parts.
