## Power Quality Inspection

Customer: **Sample Customer**

Facility: **Sample Facility**

**Server Room - Panel CB**

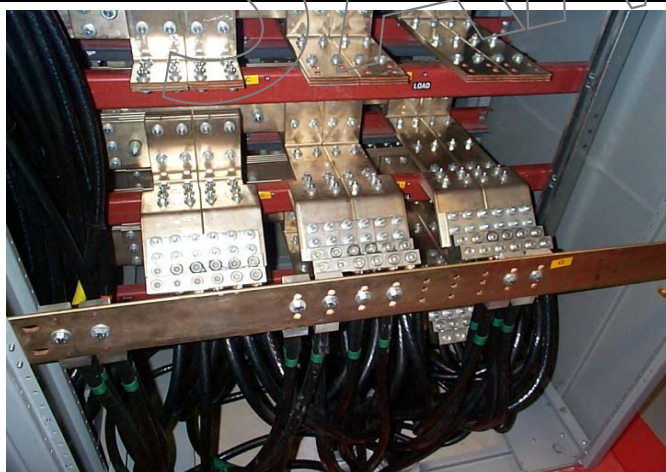
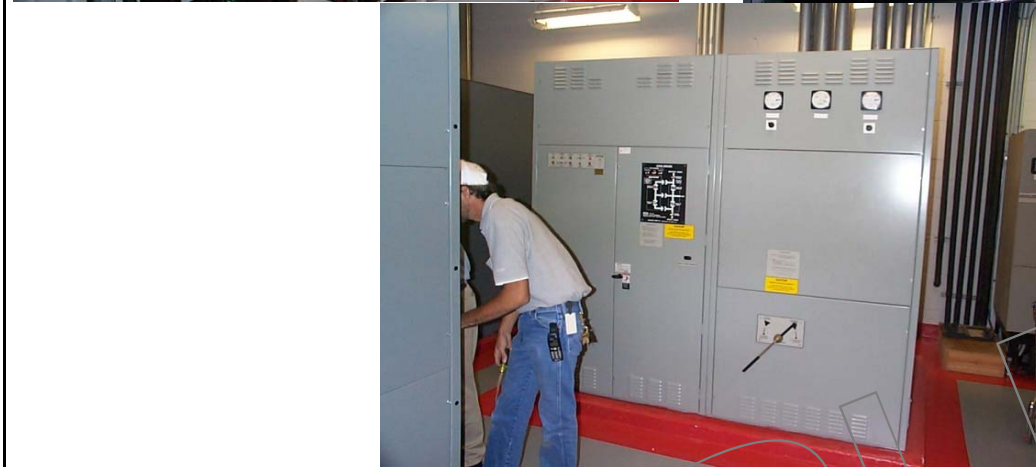
Two sets of power readings were taken at ATS #1.

One set was taken while under "normal" power, (power supplied by local utility) and the other while being fed by the generator.

In both cases, no discrepancies were found. The harmonic level, voltage ratings and current balance were found to be satisfactory.
